**Case No. 1:25-cv-22896-KMW**

**DECLARATION OF CHRISTOPHER W. McVOY, Ph.D.**

## **Analysis of Possible Areas of New Pavement at the Dade Collier Training & Transition Airport**

Dr. Christopher McVoy

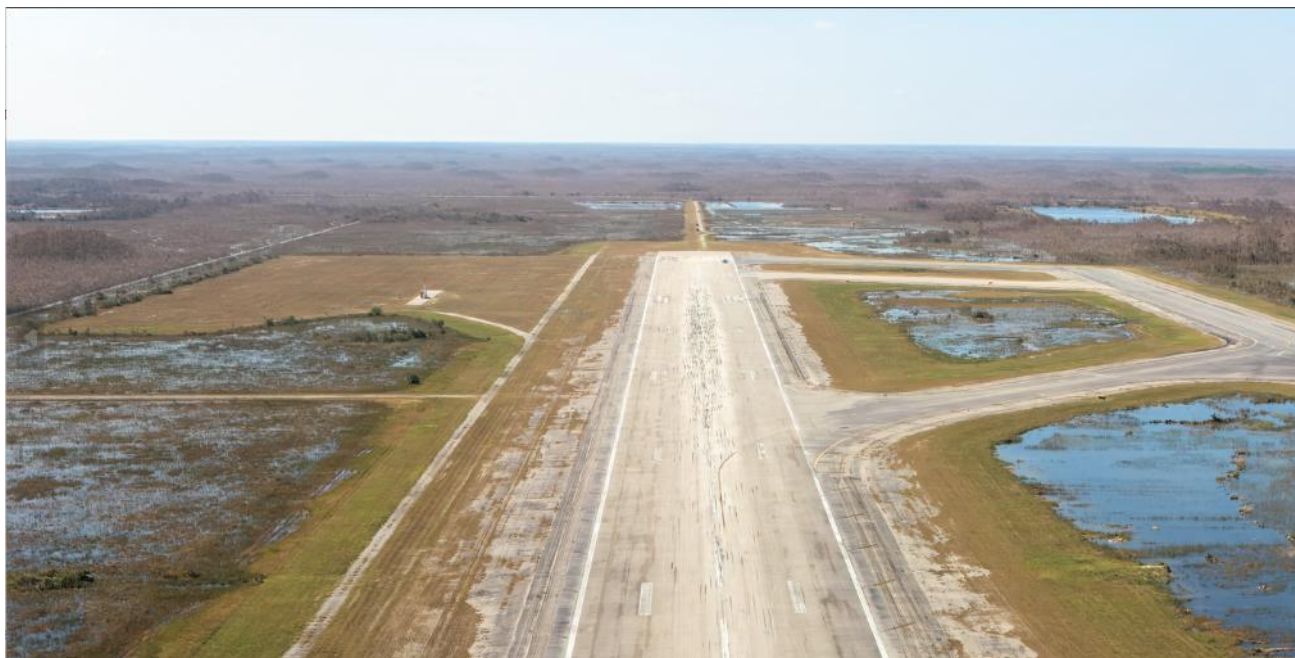
**Fig. 1.** West end of main runway of Dade Collier Training & Transition Airport, looking west on November 2, 2005. Note surface water present on the many wetlands present within the airport. Source: Ralph Arwood Photography, photo KTNT 11-02-2005 51684.

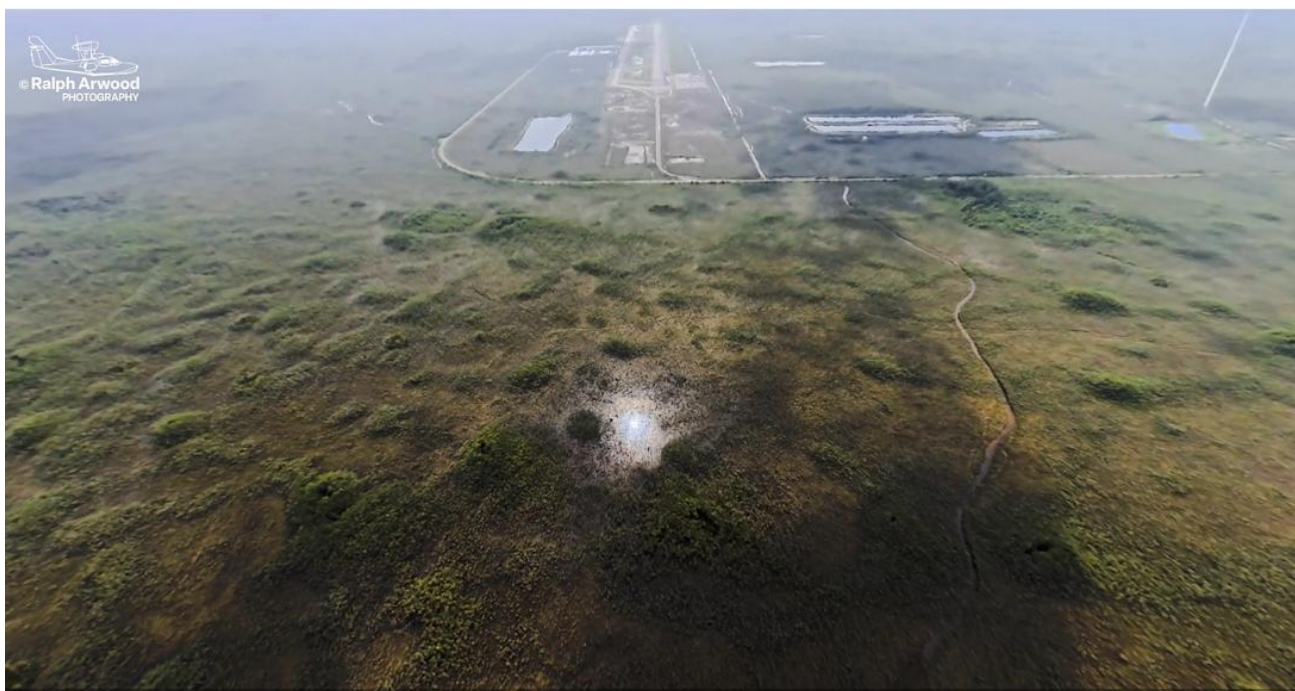
**Fig. 2.** Aerial view of Dade Collier Training & Transition Airport, looking east on July 18, 2025. Foreground is Big Cypress National Preserve, which surrounds the airport. The bright spot in foreground center is reflection of sun from surface water, present at this time throughout the area. Minute 0:10 of Video KTNT 07-18-2025 01, courtesy Ralph Arwood Photography.

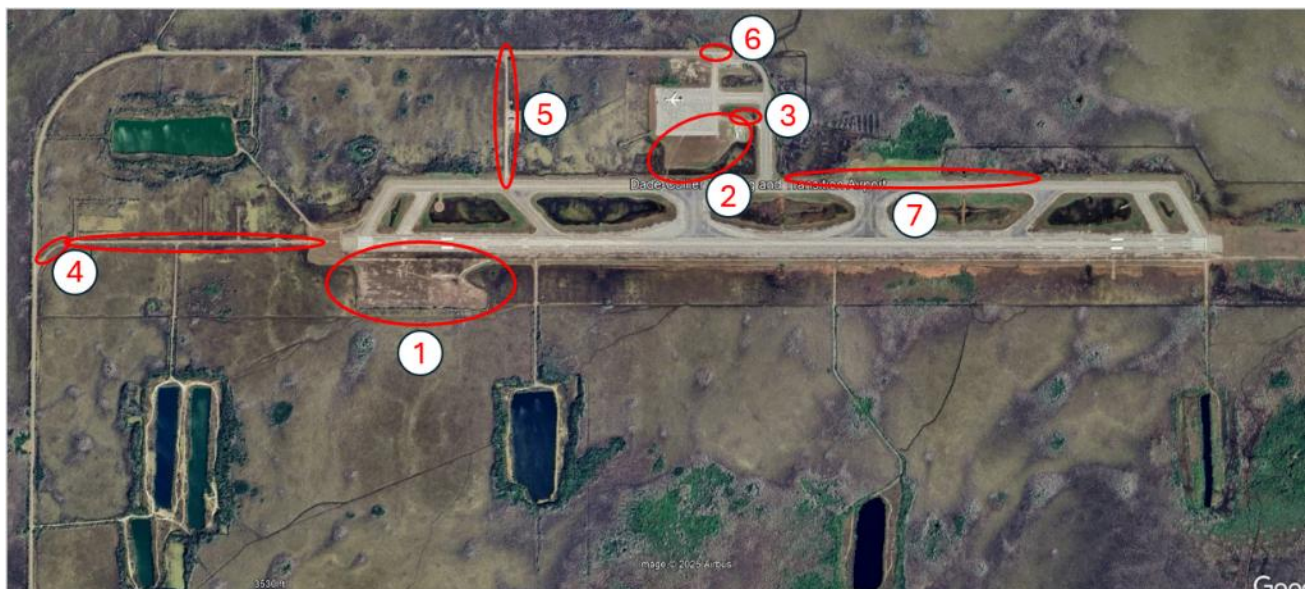
**Fig. 4.** Locator diagram for areas of asserted new paving. The two large areas, Area 1 (11+ acres) and Area 2 (7+ acres) are analyzed separately; Areas 3-7 are mostly newly paved roadways and are noted but not quantified.

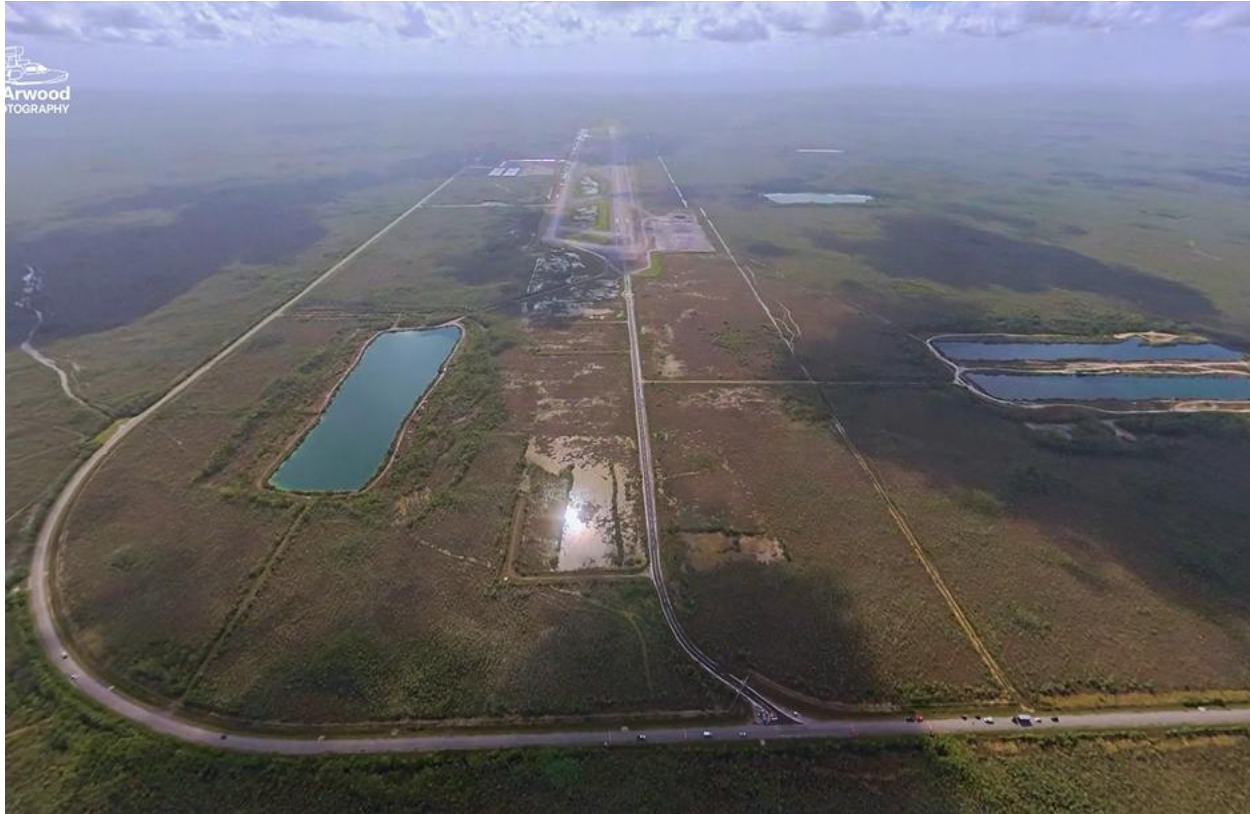
**Fig. 5.** Newly paved east-west road (“4” on the locator diagram in Fig. 4) is in center of this eastward looking photo and leads to Area 1. Source: Minute 0:09 of Video KTNT 07-11-2025 03, courtesy Ralph Arwood Photography.

Area 1, here referred to as the “Southwest Parking Area,” is the closest area to the entrance on Tamiami Trail (U.S. 41), being reached by the east-west road (“4” on the locator diagram in Fig. 4) where paving was already in progress on June 28, 2025. Its location near the west end of the runway as well as shapes of surrounding features make it easy to locate unambiguously. Fig. 5 shows the progression from a brown colored open area to paved area, to paved area with markings, and finally to paved area with many vehicles parked in the markings.

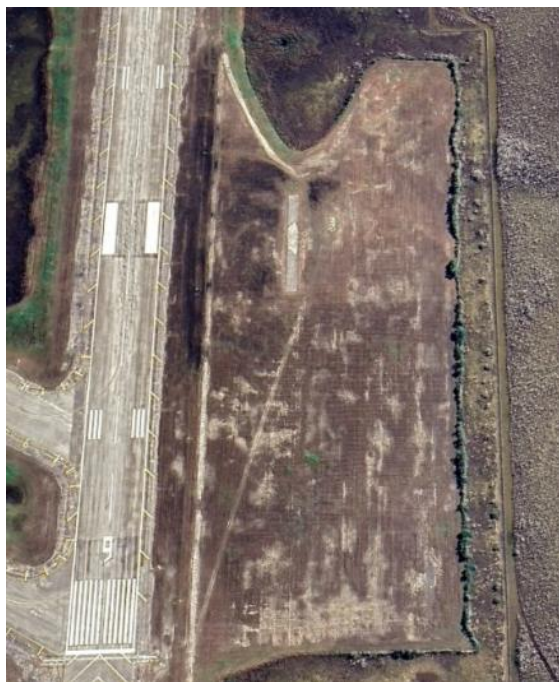
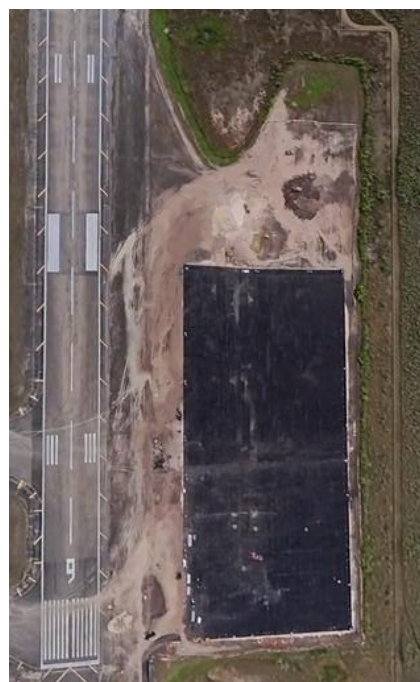
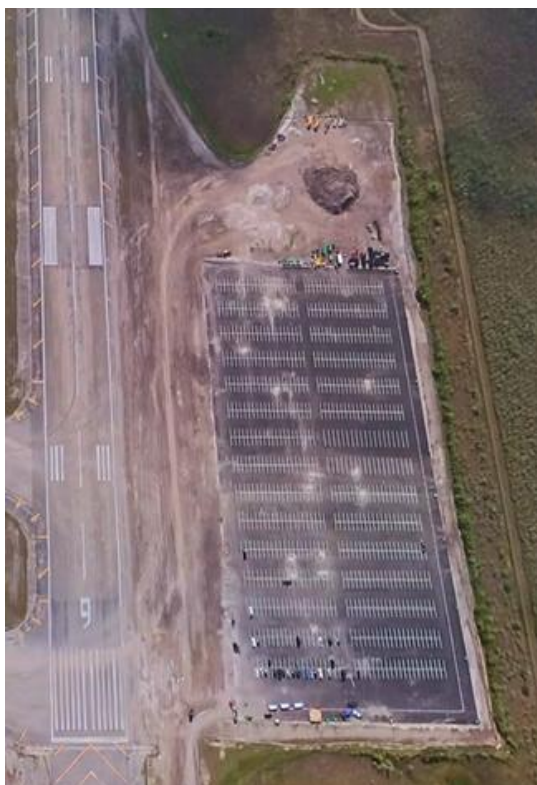
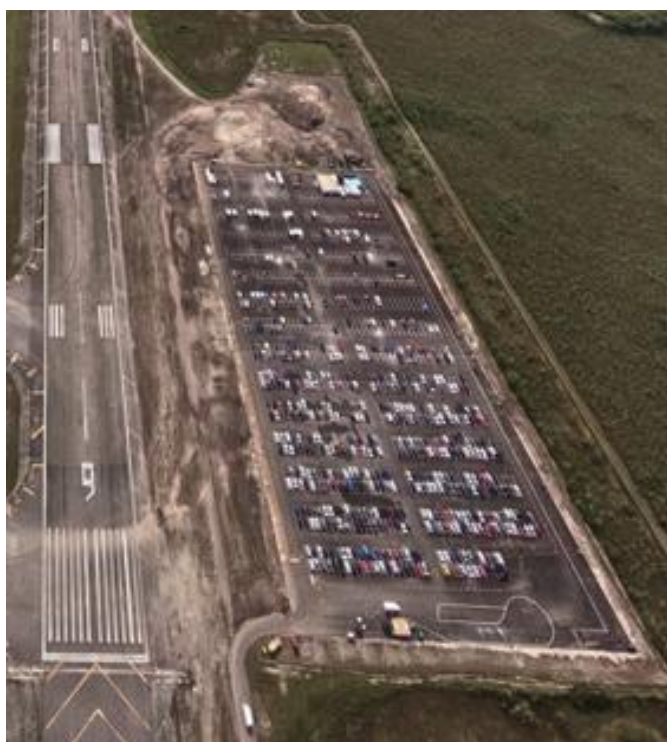
**Fig. 6.** Area 1, “Southwest Parking Area.” Time sequence of area’s appearance. Sources: Feb 21: Google Earth; Jul 05: Video KTNT 07-05-2025 03, Minute 3:40; Jul 11: Video KTNT 07-11-2025 03, Minute 0:39; Jul 18: Photo 07-18-2025 KTNT 06 25,51.721N 80,54.869W (portion). All July imagery courtesy Ralph Arwood Photography.

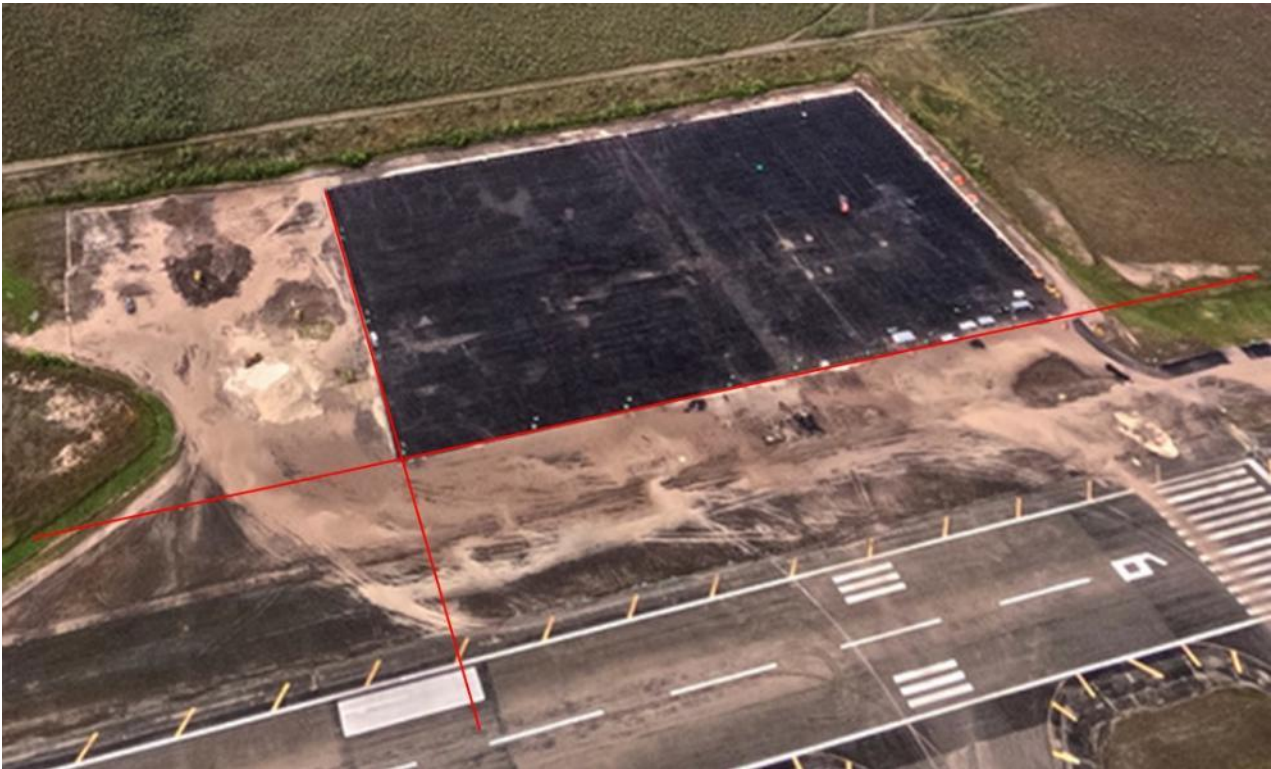
**Fig. 7.** Based on the time sequence seen in Fig. 6, the dark rectangle is assumed to newly placed asphalt. Light sandy brown area to east and north of asphalt is newly scrapped (or filled) area. Red alignment lines were used to estimate extent of assumed paved area. Photo source: 07-05-2025 KTNT 23 25,51.796N 80,54.529W (portion), courtesy Ralph Arwood Photography.

The spatial extent of Area 1, the “Southwest Parking Area,” was estimated by finding landmarks corresponding to the pavement edges seen in the aerial photographs, marking the same edges on Google Earth, then using the Google Earth “Ruler” tool.

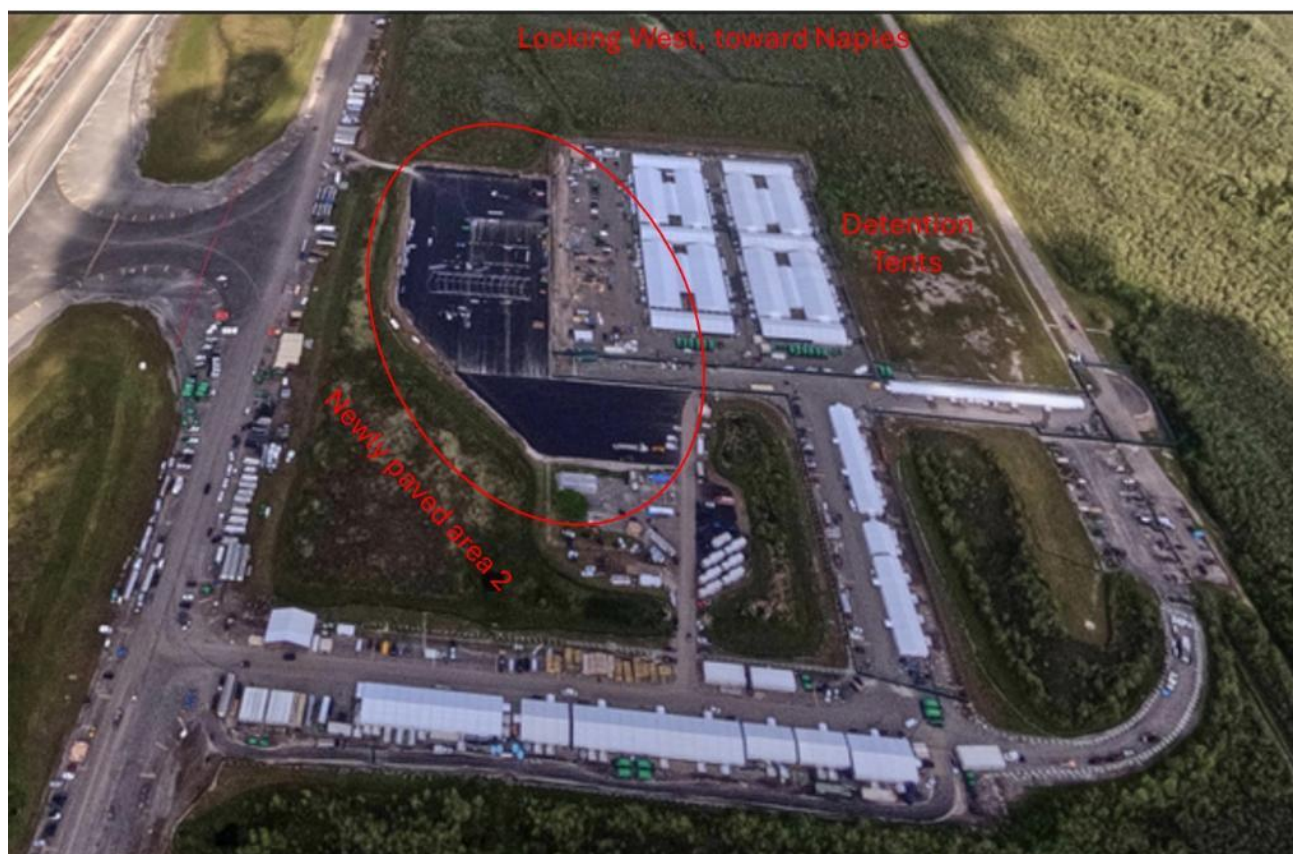
**Fig. 9.** Area 2, the “Tent Expansion Area.” Source: Photo 07-11-2025 KTNT 19 25,51.904N 80,53.699W (portion). Courtesy Ralph Arwood Photography.

Area 2, the “Tent Expansion Area” is an expansion of a large rectangular area that was paved in the late 1960s as part of the original Jetport.

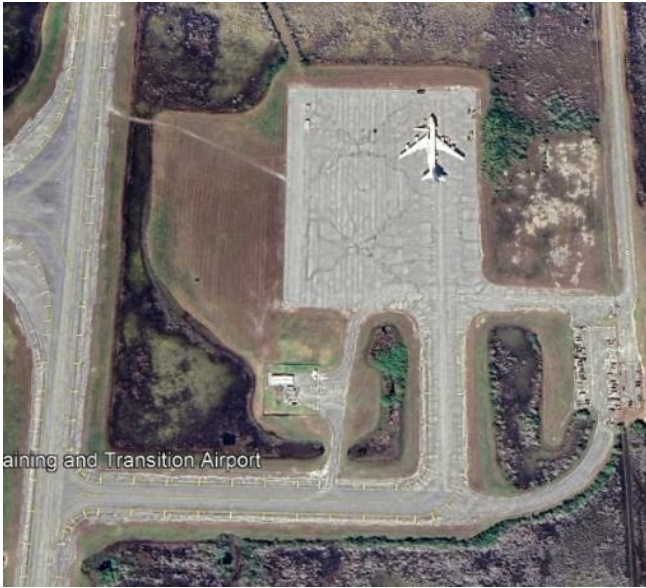
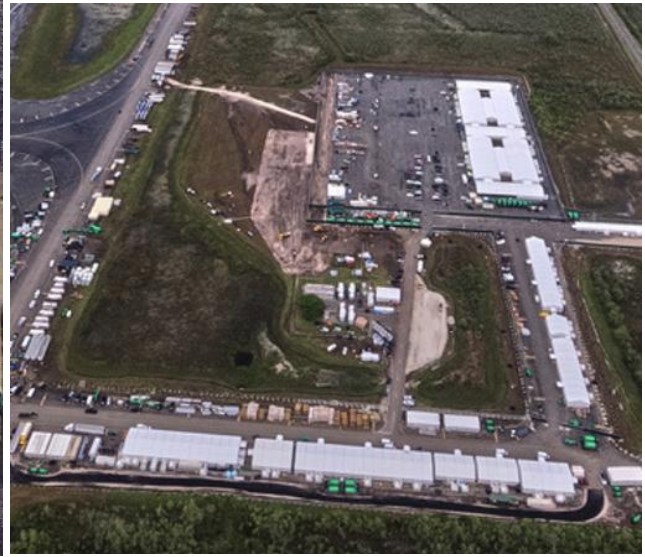
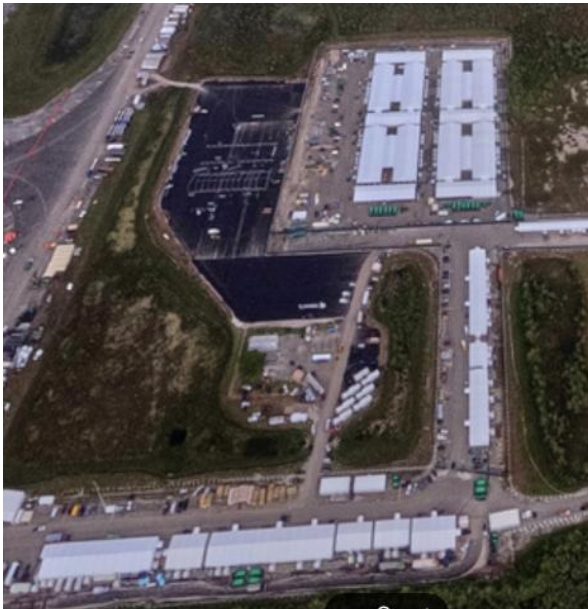
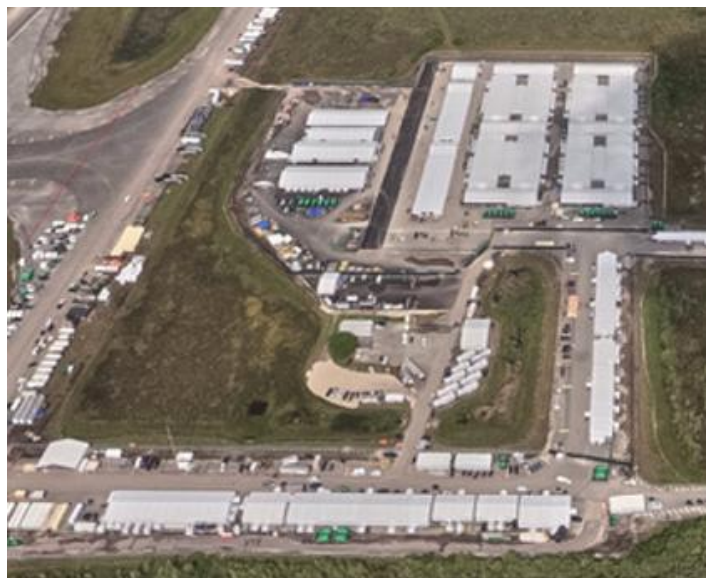
**Fig. 10.** Area 2, “Tent Expansion Area.” Time sequence of area’s appearance. Sources: Feb 21: Google Earth; Jul 05: Photo 07-05-2025 KTNT 08 25,51.938N 80,53.692W (portion); Jul 11: Photo 07-11-2025 KTNT 36 25,52.013N 80,53.704W (portion); Jul 18: Photo 07-18-2025 KTNT 26 25,52.018N 80,53.752W (portion). All July imagery courtesy Ralph Arwood Photography.

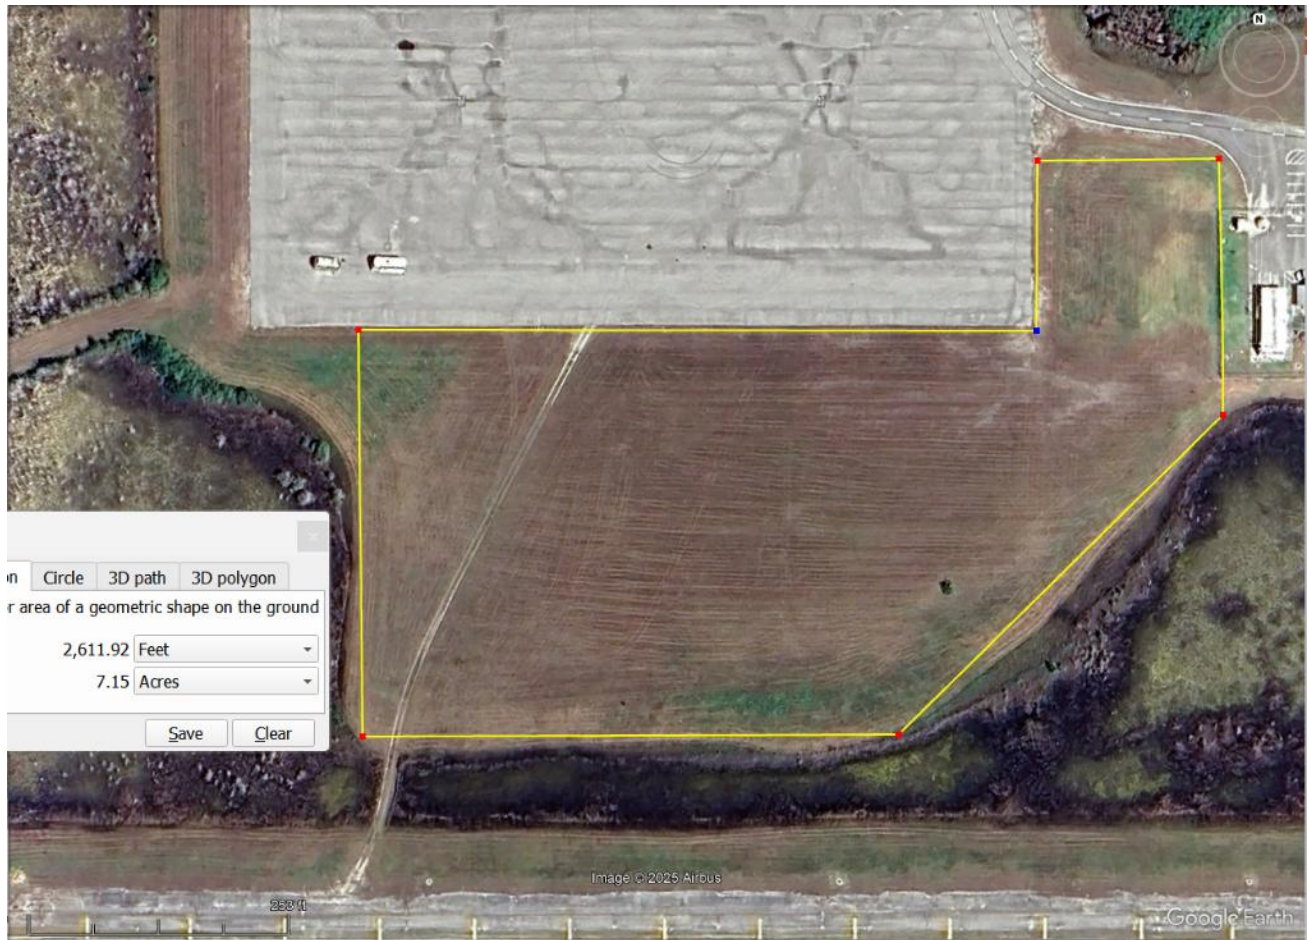
**Fig. 11.** Untilted, unrotated Google Earth image used to estimate extent of paved Area 2. This newly paved area is estimated to be 7+ acres.

The spatial extent of Area 2, the “Tent Expansion Area,” was estimated by finding landmarks corresponding to the pavement edges seen in the aerial photographs, marking the same edges on Google Earth, then using the Google Earth “Ruler” tool.

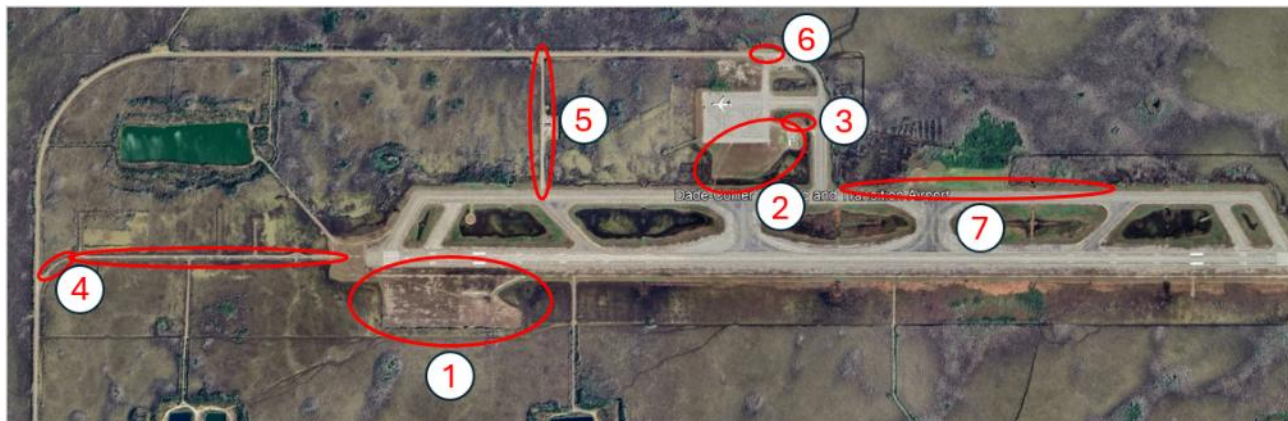
**Fig. 12.** Locator diagram for Areas 3-7, which are mostly newly paved roadways and are noted here but were not not quantified.

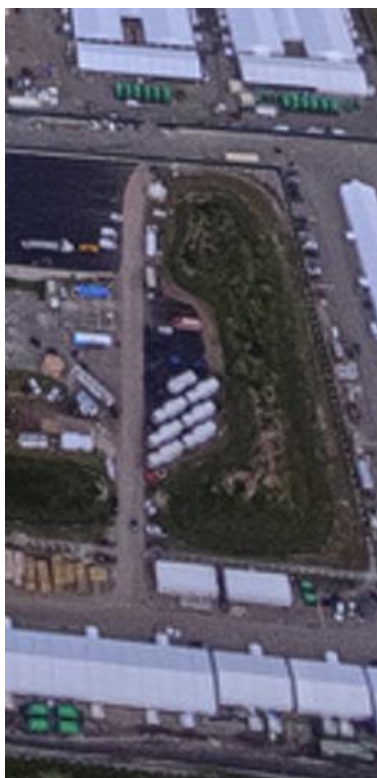
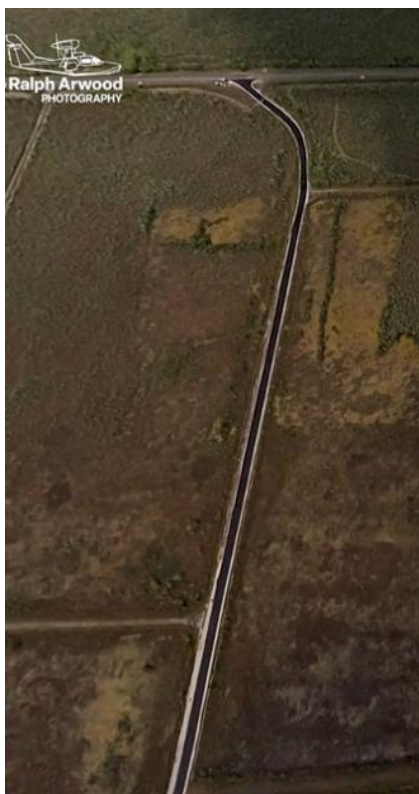
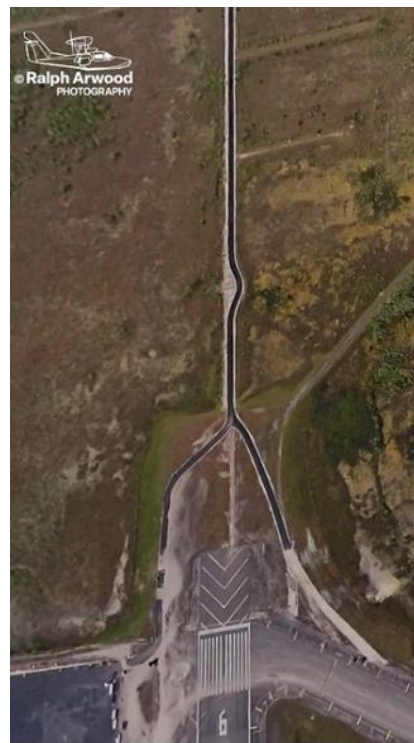
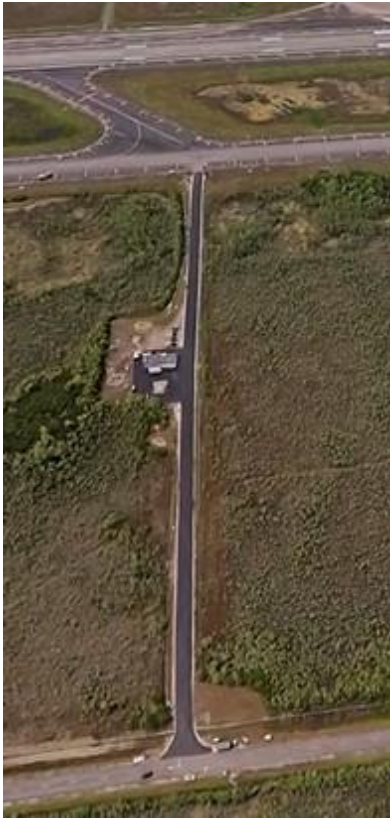
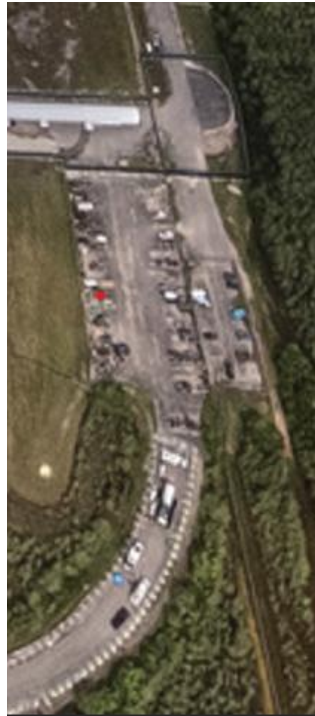
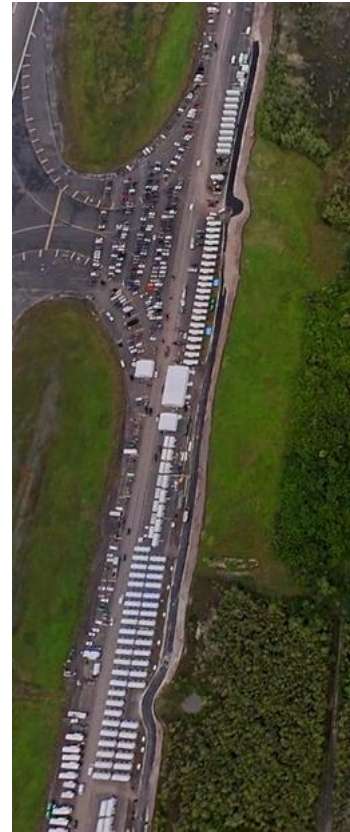
**Fig. 13.** Smaller areas of new paving.

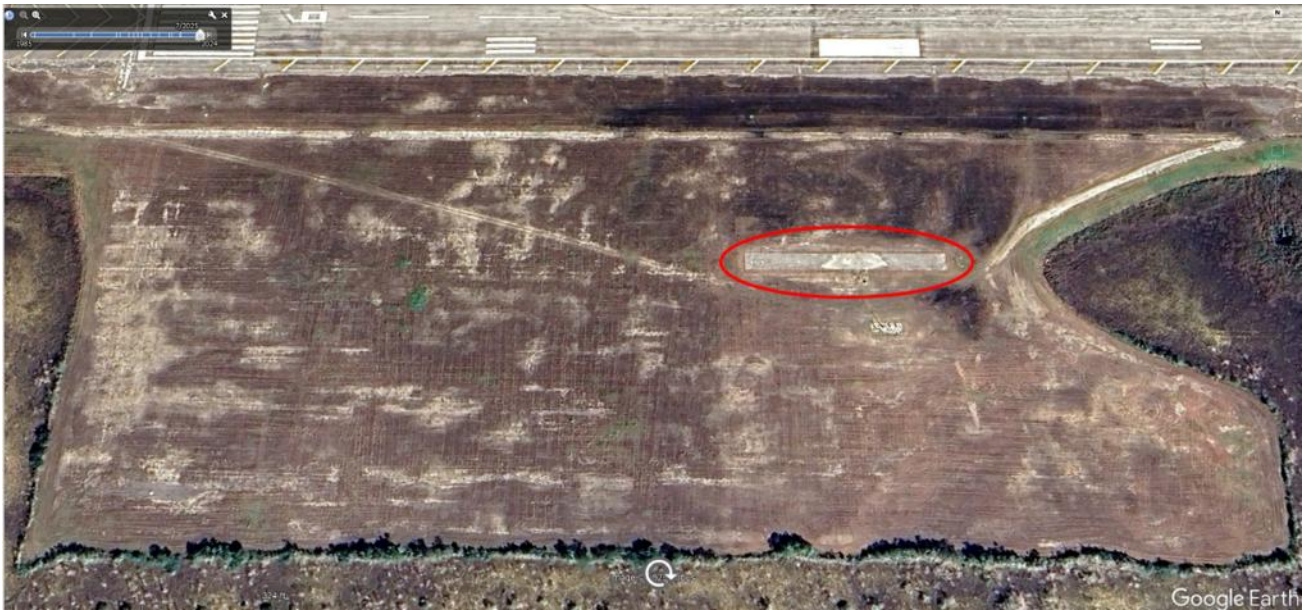
**Fig. 14.** Area 1, the “Southwest Parking Area.” Satellite image from Feb 21, 2025 (prior to any detention center construction). Note the N-S and E-W patterning, which is likely from equipment such as mowers or brush hogs criss-crossing this area. Vegetation that needed mowing would not grow on top of cement. The red oval identifies an actual, very small cement pad.

I can find no evidence to support the statement by Ms. Stephanie Hartman indicating a pre-existing cement pad. Instead, all the historical imagery I found suggests that the area was cleared of vegetation, and perhaps also leveled, probably at the same time that the runway was constructed (ca. 1968-70). Patterns in the historical imagery suggest systematic traversing of the area by equipment, likely by large mowers or brush hogs. A "thin layer of dirt and grass" on top of a cement pad would be unlikely to need mowing and would be very unlikely to produce the patterns seen. Additionally, the high rainfall intensity of South Florida thunderstorms would likely prevent the accumulation of anything more than a few millimeters of unconsolidated sediments on a cement pad. A layer that thin would not support sufficient growth to require mowing.

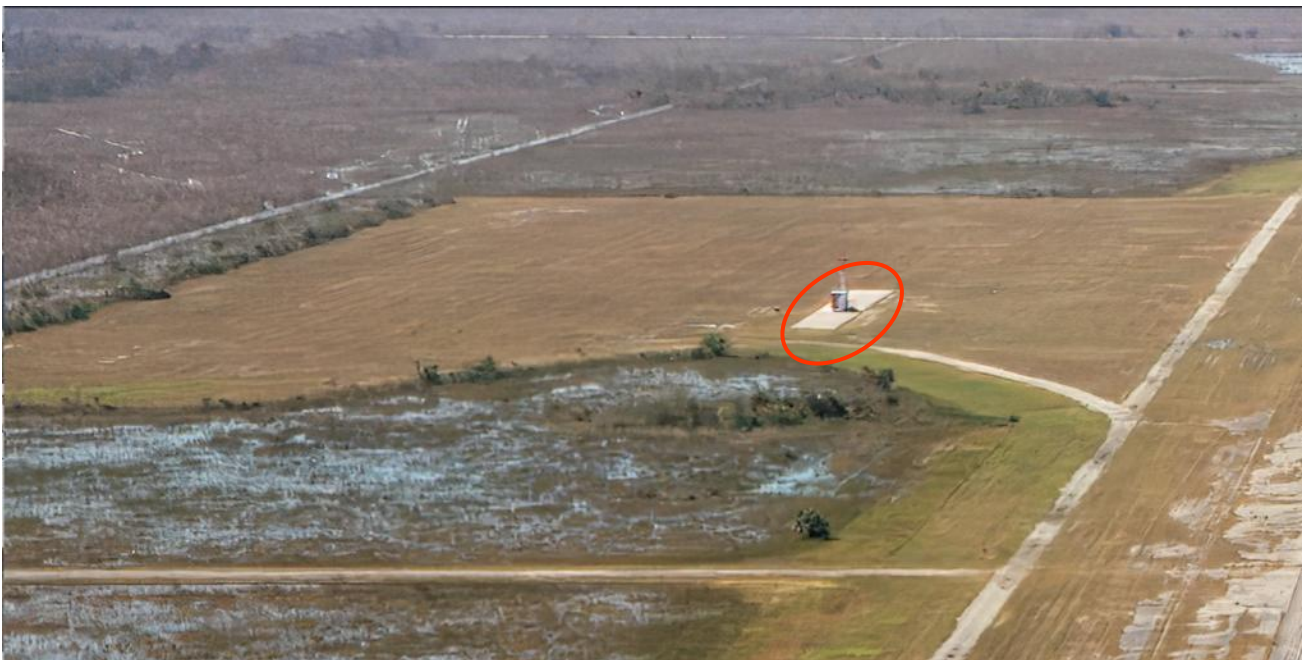
**Fig. 15.** Area 1, the “Southwest Parking Area,” seen in an oblique aerial photo, looking WSW. The red oval indicates an actual, very small cement pad, seen also in the satellite imagery (Fig. 14).

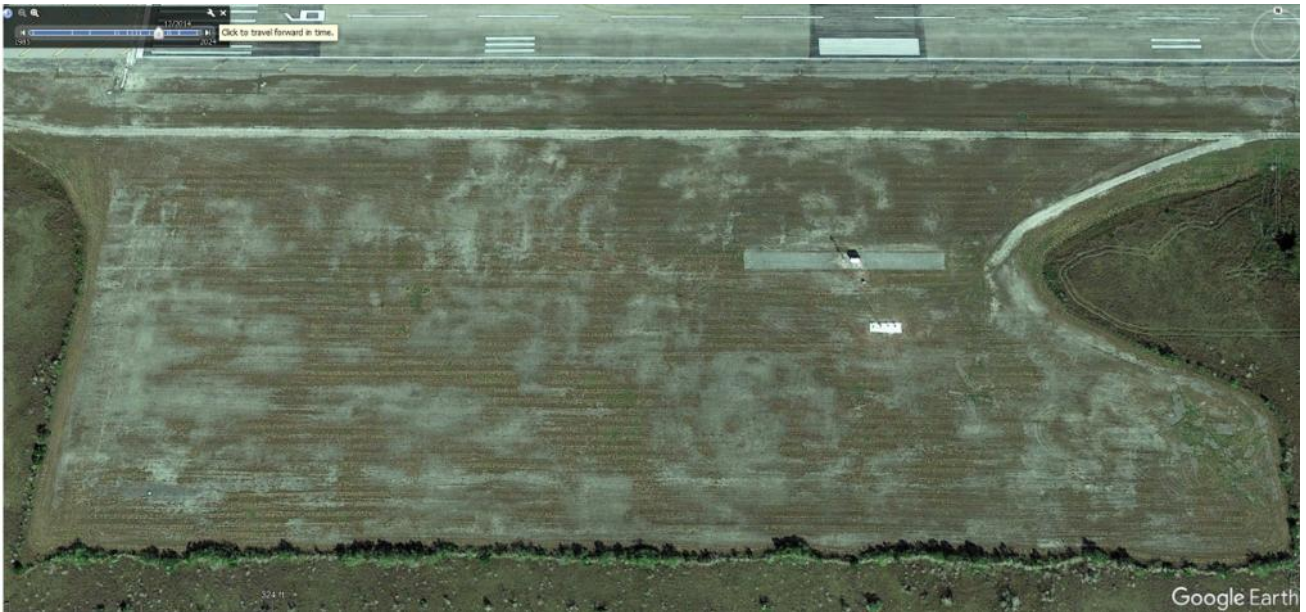
**Fig. 16.** Area 1, the “Southwest Parking Area.” Satellite image from 2014. Note the E-W patterning, which is likely from mowing equipment. Vegetation that needed mowing would not grow on top of cement.

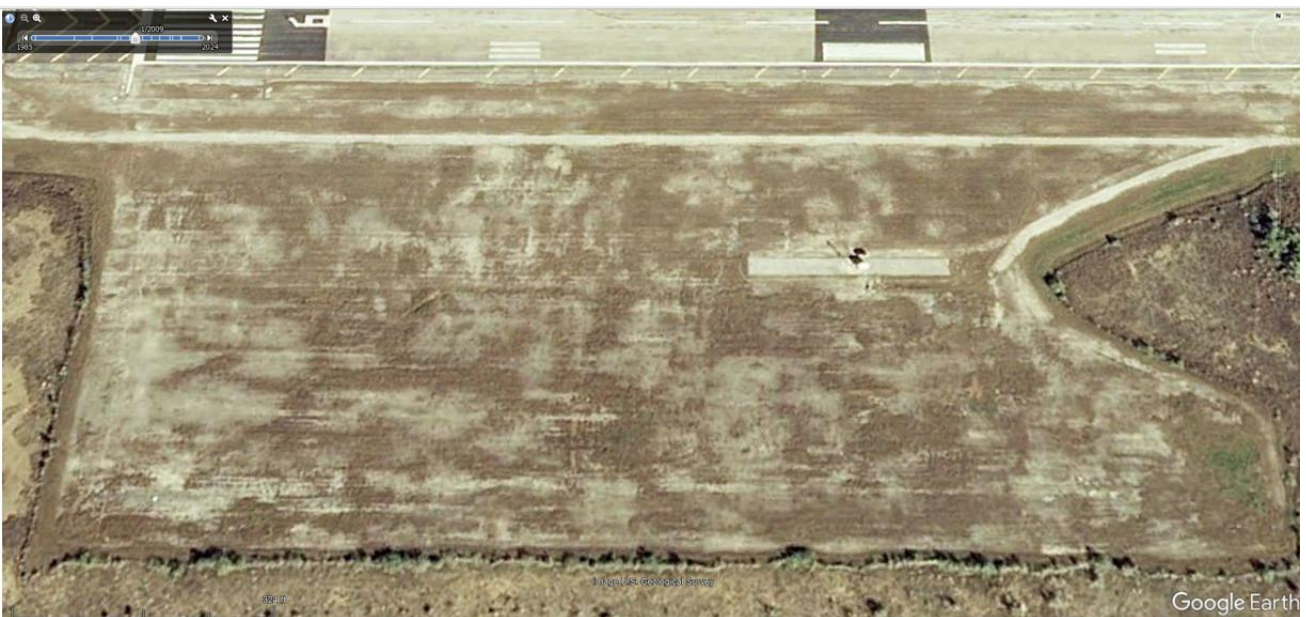
**Fig. 16.** Area 1, the “Southwest Parking Area.” Satellite image from 2009. Note the E-W patterning, which is likely from mowing equipment. Vegetation that needed mowing would not grow on top of cement.

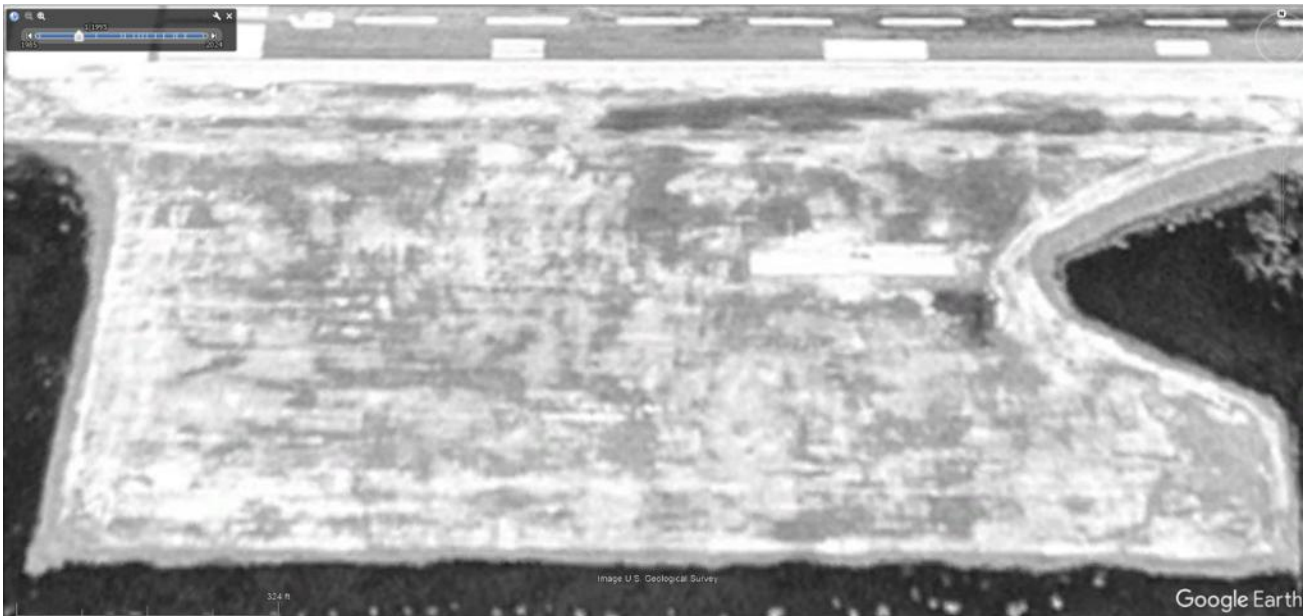
**Fig. 16.** Area 1, the “Southwest Parking Area.” Satellite image from 1995. Even in this low resolution image, an indication of the E-W patterning, likely from mowing, is apparent.

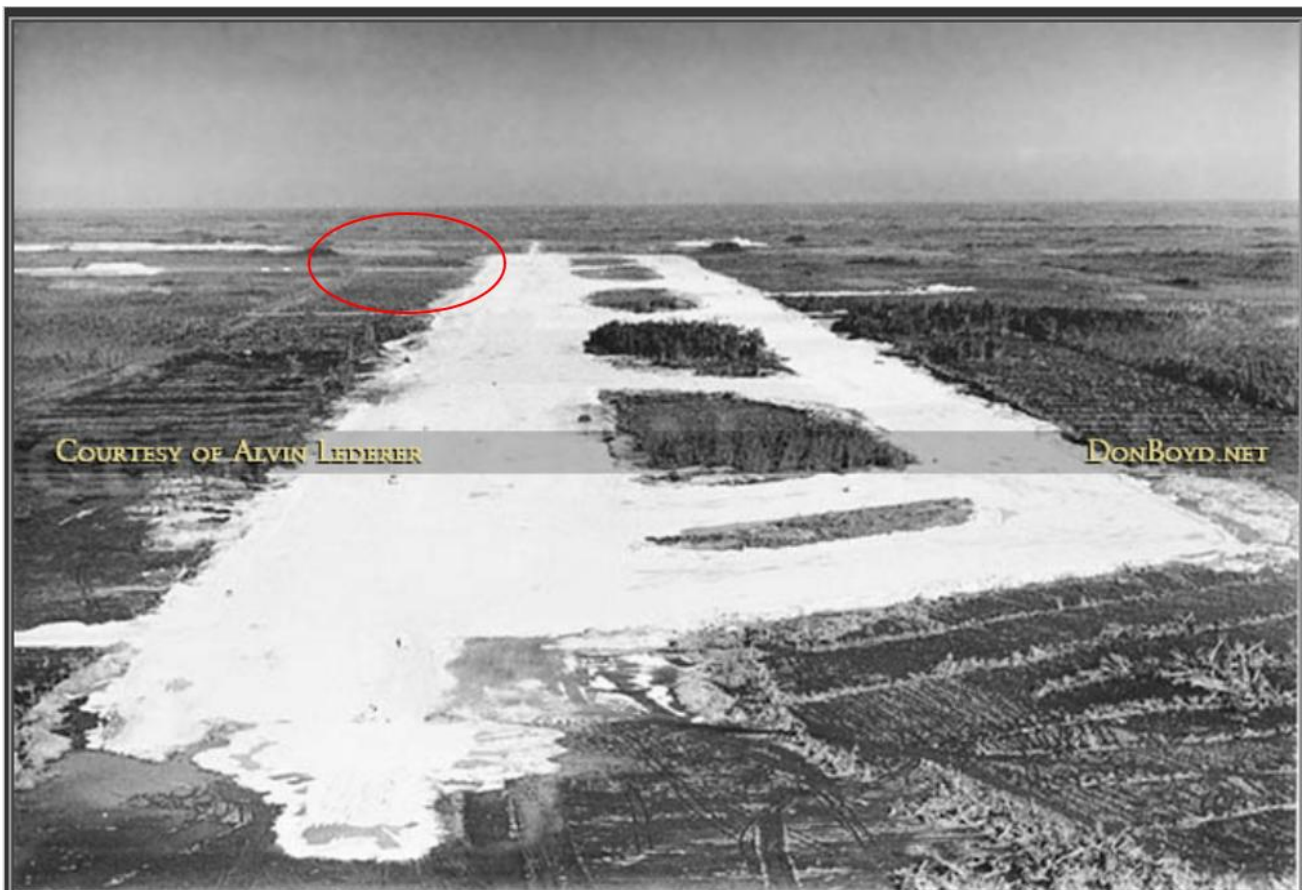
**Fig. 17.** “1970 - aerial view of the Dade County Training & Transition Airport under construction.” Red oval is indicates the location of Area 1. There is no indication that Area 1 was a cement pad in 1970, the year construction was halted. Source: <https://pbase.com/donboyd/image/165484225>

Examination of multiple years of historical imagery suggests that the newly asphalted areas (Areas 1 and 2) most likely were areas of original soil, cleared of brush and trees around 1970, and subsequently kept to low vegetation by periodic mowing. While there might well have been an original intent to cover with a cement pad, there is no indication that such a pad was ever installed.

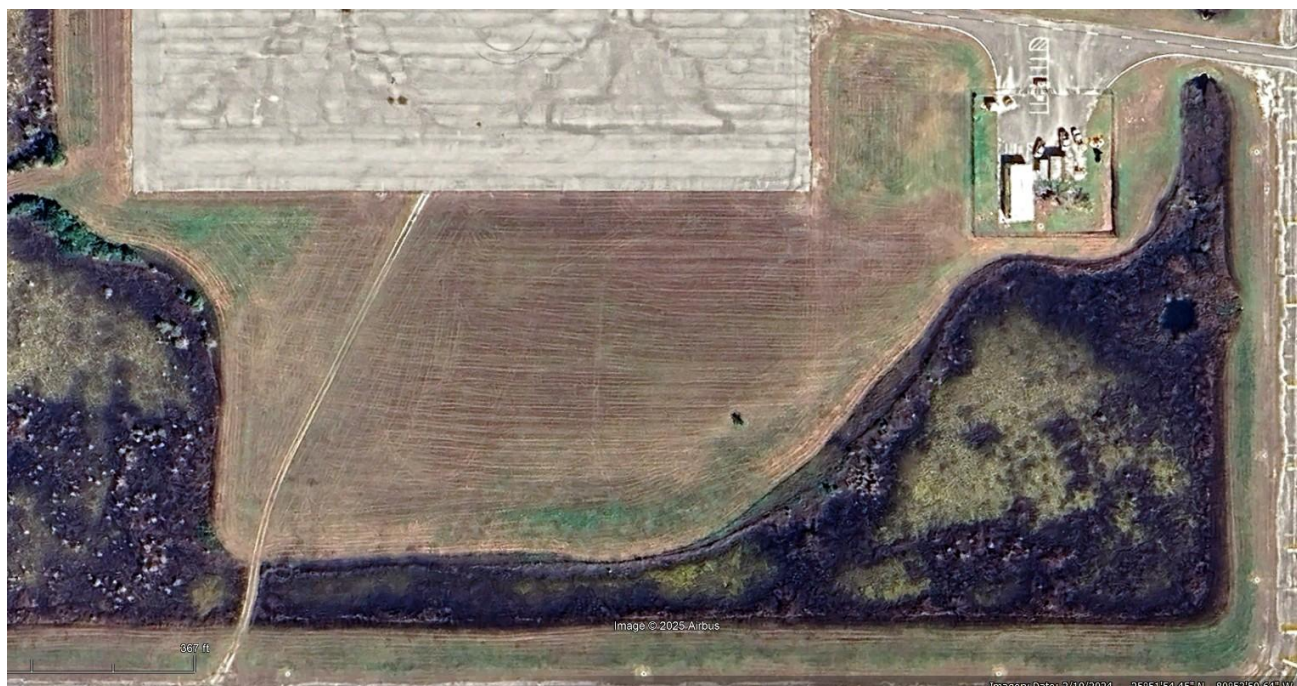
**Fig. 18.** Area 2, the “Tent Expansion Area.” Satellite image from 2024. Note the mostly E-W patterning, which is likely from mowing equipment. Source: Google Earth.

Similar mowing patterns are visible for Area 2, the "Tent Expansion Area" (location: Fig. 4) in historical satellite imagery. Figs. 18 and 19 show two examples.

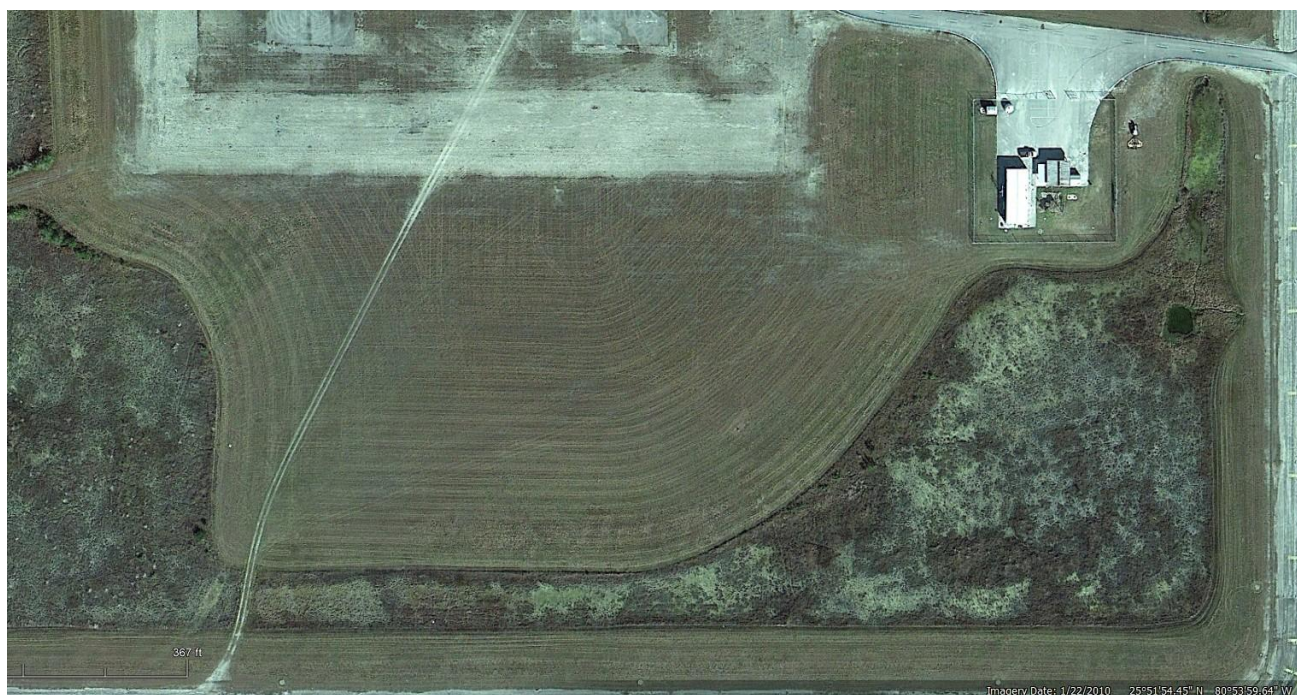
**Fig. 19.** Area 2, the “Tent Expansion Area.” Satellite image from 2010. Mowing pattern is particularly visible in this year. Source: Google Earth.
